SAM YU Building Inspection Services
Inspection Report
(604) 351-2313

**This home is a single family, 2 storey dwelling.
This property is located on a flat lot and was constructed in 1961.
Weather at time of inspection was cool and cloudy/clear.**

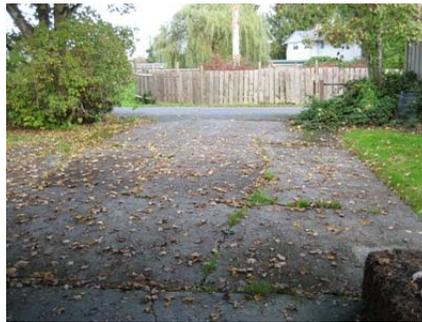
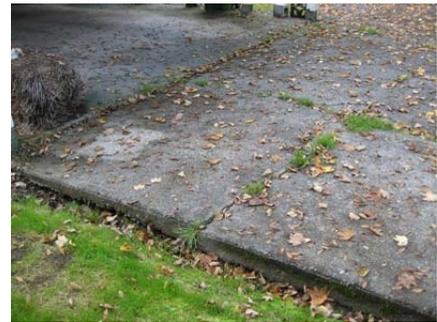
101 Driveway: Concrete. Settling. Common cracking noted. Lane access.

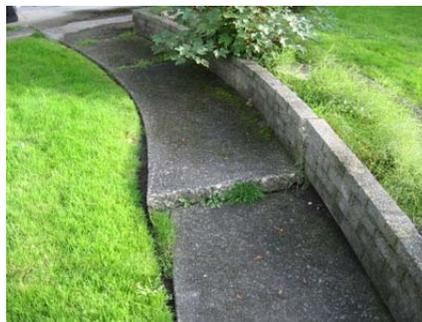
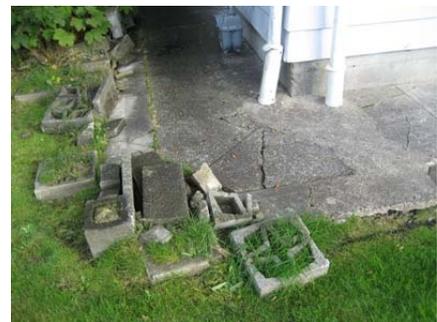
102 Walks: Concrete. Settling and cracking at front. Trip hazards, Repair as required.

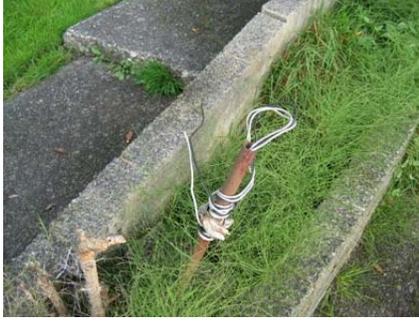
107 Elec. Fixtures: No outlet noted.
Disconnected electric wires terminated at front walkway. No power at time of inspection. Appear has been abandoned.

Suggest to be verified by electrician.

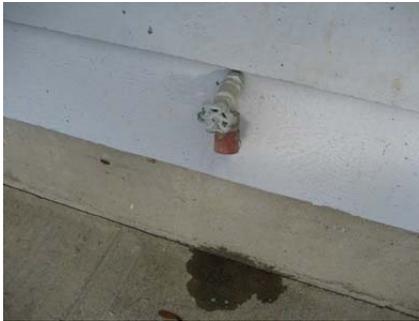
No water at front hosebib, possible winterized. Generally it is recommended that outside valves and water pipes are shut off and drained during the time of the winter that freezing weather could occur. This could prevent freezing and cracking the exterior piping.

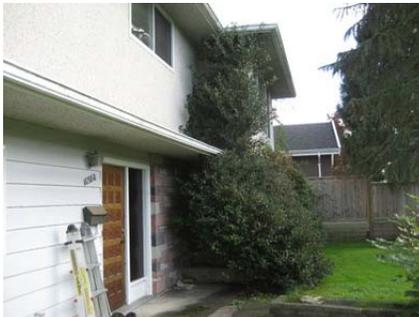
Home is built on a flat lot. Grade at foundation appears to be adequate. Appear has been upgraded. It is beyond the scope of our inspection to verify underground drainage systems. Client may wish to obtain further review from a qualified contractor and have perimeter drains checked and cleaned.

Recommend trimming back vegetation in contact with structure to prevent possible deterioration.

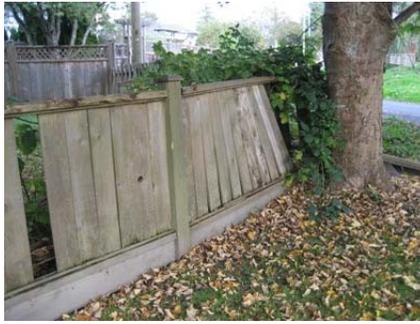
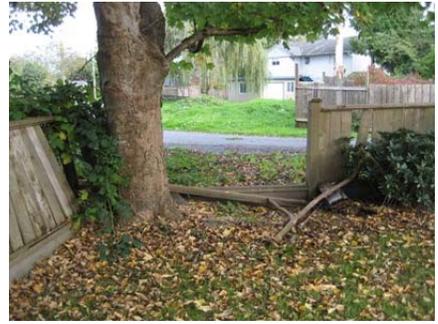
Wood fence leaning/damaged at rear yard.

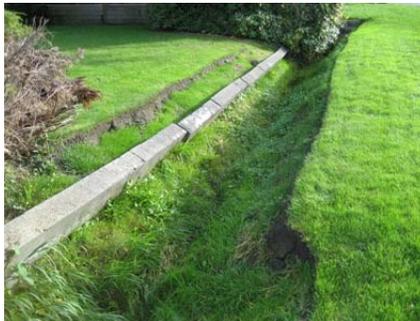
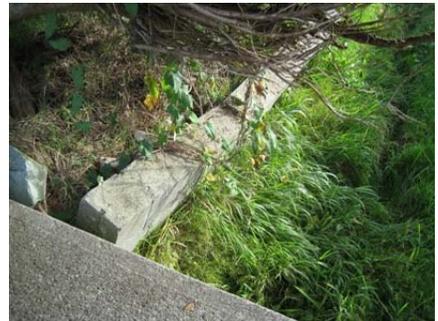
Loose/leaning concrete block, located at front near ditch. Repair as required.

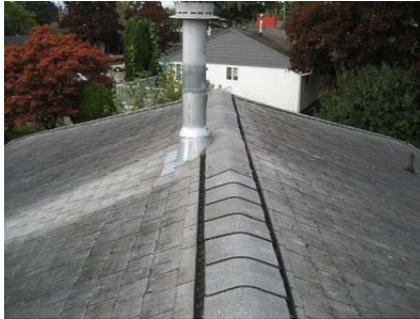
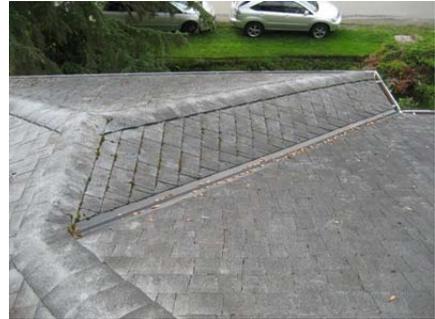
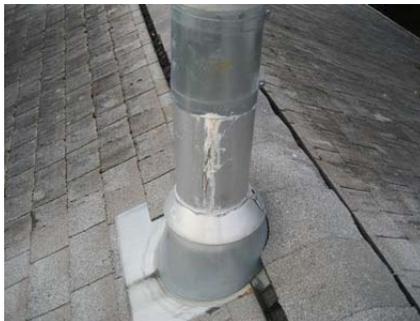
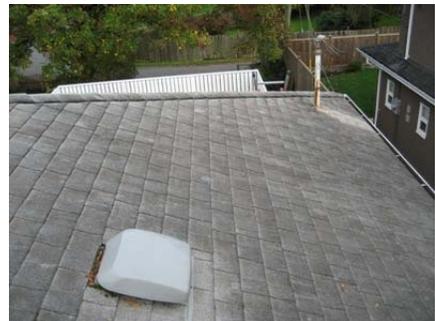
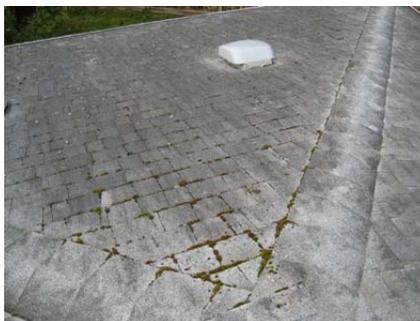
- 126 Type/Material/Access: Sloped construction, Composite shingle covering.
- 127 Access: Observed from roof.
- 128 Flashing: Suggest re-sealing all through roof vents and projections as part of routine maintenance.
- 129 Roof Comments: Roof shows normal wear for its age and type; appears to be in serviceable condition.
Some moss on shingles noted. Suggest preventative maintenance be performed for moss coverage.
Discolouration due to stains from gas vent. Corrosion noted on gas vent.

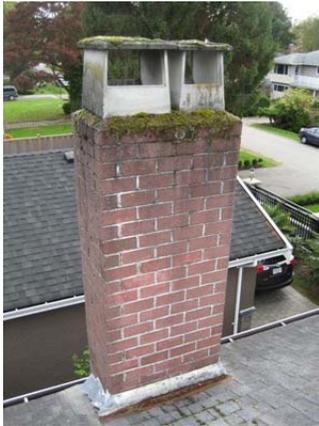
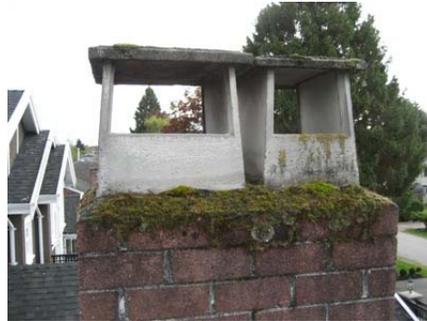
- 130 Skylights: N
- 131 Chimneys: Masonry. Common cracking noted. Moss cover on top of chimney crown.

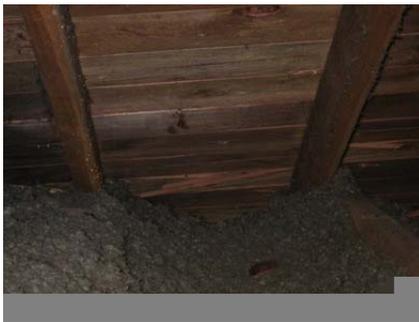
Serviceable. Solid. Minor damaged.

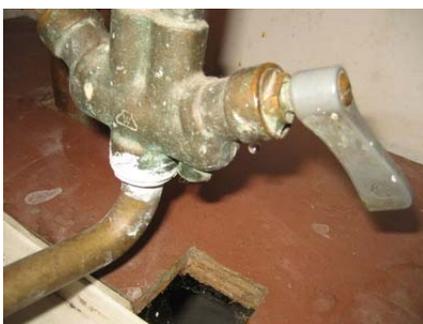
Faucet dripping leak. Repair or replace as required.

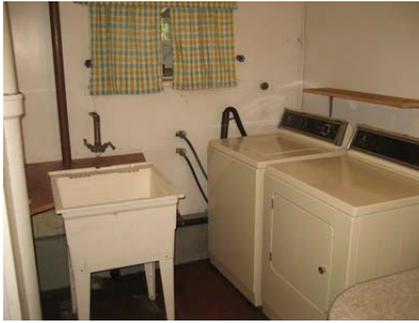
Limited review due to personal effects and/or restricted access. Washer and dryer not tested/inspected. According to the Home Inspectors Association BC scope of inspection, referenced in our inspection contract, appliances are not included in this inspection service.

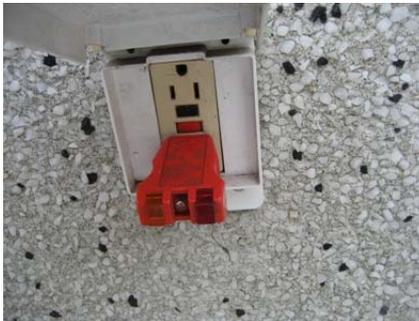
Outlet Inoperable at time of inspection. Repair or replace as required.

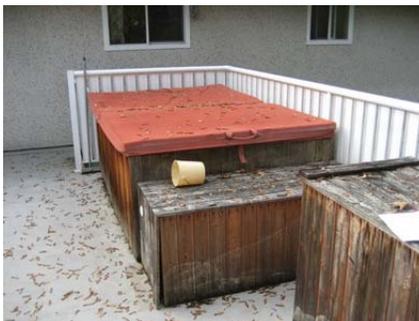
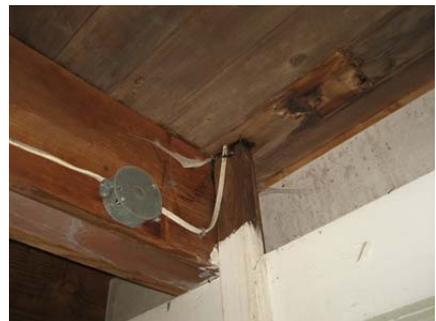
Wood with waterproof membrane. Standing water around hot tub. Over time, this water may leak under the deck covering and cause water damage to the decking and framing members below. We recommend improving the drainage to prevent water from ponding on the deck.

Water stains at deck underside, located below hot tub. No water noted but evidence of previous leaks.

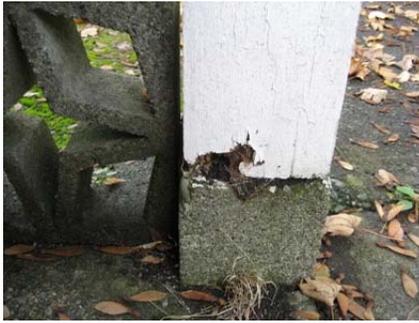
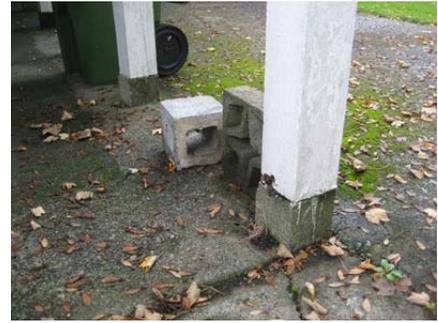
Deterioration noted at base of wood support post. Repair as required.

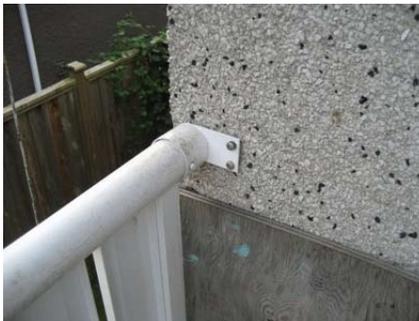
204 Stairs: Serviceable.
 205 Railing: Metal. Loosing screws attached to wall. Suggest to be tightened.

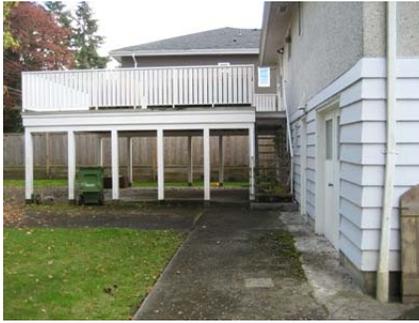
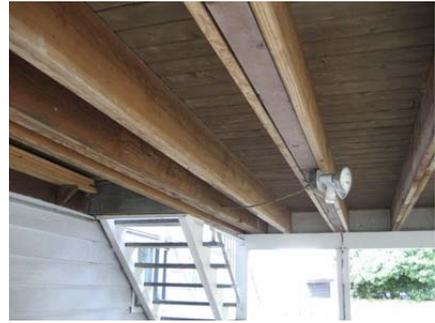
301 Exterior: See exterior comments #100.
 302 Roof: Deck above.
 303 Slab: Concrete. Common cracking noted.
 304 Garage Door: N
 305 Garage Door Hdwr: N
 306 Door Opener: N
 307 Windows: N
 308 Fire Door: N
 309 Fire Wall: N
 310 Service Door: N
 311 Walls: N
 312 Ceiling: Refer to Deck #203.
 313 Electrical: Exposed wires noted.
 314 Comments: N

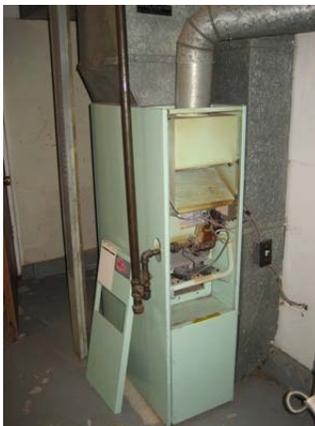
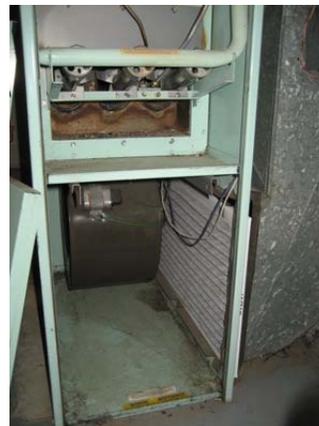
Operate when tested. Old model. Due to the presence of rust, scale, and some debris in this appliance, a service review is advised to ensure proper operation. Gas shut off provided. It is recommended that heating systems be serviced by a qualified heating contractor on an annual basis to ensure safe and proper operation.

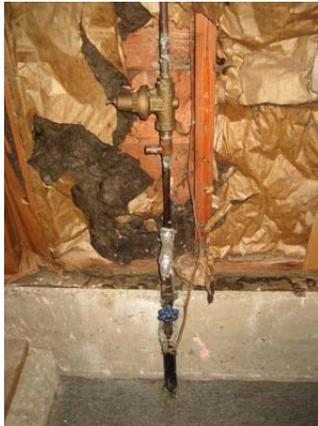
Water supply provided by public system. Main water shut off is located at lower level front wall. Water pressure regulator noted.

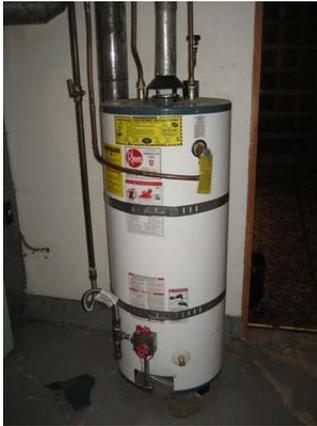
Approximate capacity is 40 gallons. Unit is gas fired. Appears to have been manufactured in 2003. Cold water shut off noted. Gas shut off located near water heater. Pressure & temperature relief valve installed as a safety feature. A discharge pipe on pressure & temperature relief valve was not properly installed. Recommend a review by a qualified contractor. Recommend draining one bucket of water annually from tank to remove tank residue, thereby extending life of tank. If the water tank is gas powered, recommend strapping to prevent tipping or moving excessively during an earthquake. This is for fire prevention since gas lines around hot water tanks are known to crack or break during a significant earthquake.

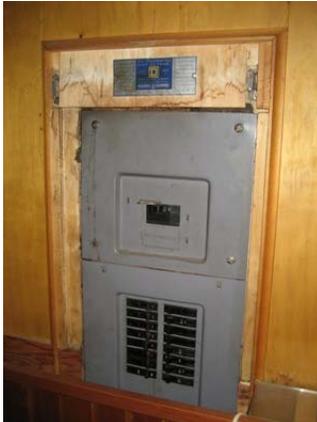
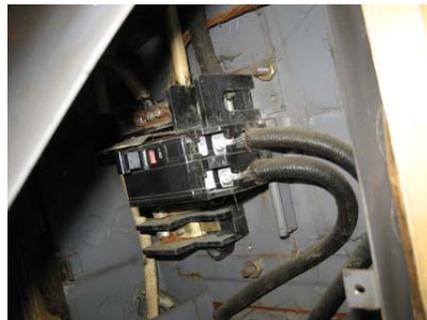
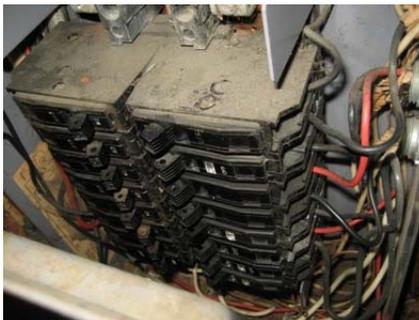
The electrical service is approximately 100 amps (70 amp main breaker installed), 120/240 volts. Service entrance is overhead. Main panel located at lower level front room. Limited review due to panel cover was not able to be removed, only partially open for review. Main service conductor is copper. Overload protection is provided by breakers. Main disconnect noted. Extra breaker spaces not provided for possible expansion. Low amperage branch circuit conductor is copper, preferred for safety. No solid aluminium branch wiring was viewed in the house. Wiring in home is three conductor encased cable (Loomex). Grounding system is present.

safety feature that may or may not have been required in various areas of the home when built. We suggest client consider upgrading with GFI's at all receptacles near water sources, such as the kitchen, bathrooms, garage, and exterior outlets to enhance electrical safety.

Reversed Polarity, hot and ground reversed, open neutral and other terms used for electric outlets are usually easily corrected by minor wiring adjustments. The inspector only tests a random sample of outlets. Proper wiring is important for electrical safety in the home. The preceding conditions should be reviewed by a qualified electrician and repaired or replaced as required.

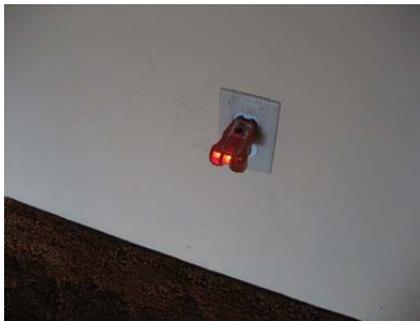
- 601 Floor: Serviceable. Vinyl.
- 602 Walls/Ceilings: Serviceable.
- 604 Doors: Serviceable.
- 605 Window/Skylights: Serviceable.
- 606 Electrical: Reversed polarity to outlets at dining areas noted. See #408.

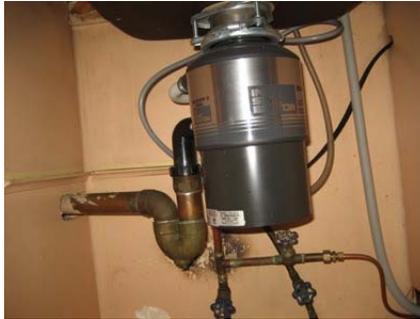
- 607 Heating: Forced air ducts.
- 608 Cabinets: Serviceable.
- 609 Counter Tops: Serviceable.
- 610 Sinks: Serviceable. Single bowl, stainless steel.
- 611 Faucets: Serviceable.
- 612 Drain/Supply Pipes: Serviceable.
- 613 Disposal: Garbage disposal vibrates and shudders indicating unit may contain foreign matter, have loose, frozen, bent, broken or missing blades. Unit may require tightening or replacing to correct these problems.

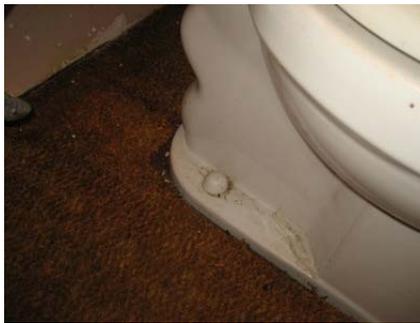
- 706 Windows/Skylights: Serviceable.
- 707 Exhaust Fan: Suggest the installation of an exhaust fan vented to exterior to dissipate excess moisture.
- 708 Heating: N
- 709 Tub/Surround: N
- 710 Tub Encl.: N
- 711 Tub Faucet: N
- 712 Shower/Surround: N
- 713 Shower Door: N
- 714 Shower Head: N
- 715 Sink: Serviceable.
- 716 Sink Faucet: Serviceable.
- 717 Drain/Supply Pipes: Serviceable.
- 718 Toilet: The toilet bowl is loose at floor anchor bolts. The wax ring inside the unit must have a snug, secure fit in order to keep from leaking. Properly resealing and re-securing this unit is suggested to prevent water leakage and damage.

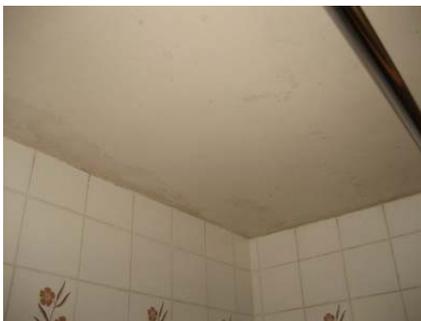
Moisture stains at ceiling above bath tub due to inadequate ventilation. See comment #757.

Suggest the installation of an exhaust fan vented to exterior to dissipate excess moisture.

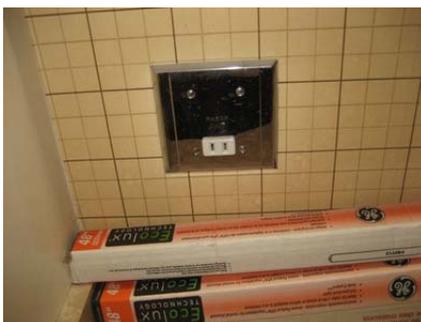
Razor outlet noted. This outlet is only intended for low voltage appliances, specifically razors. Overheating may occur with use of other appliances. Recommend upgrading to Ground Fault Interrupter outlet for enhanced safety.

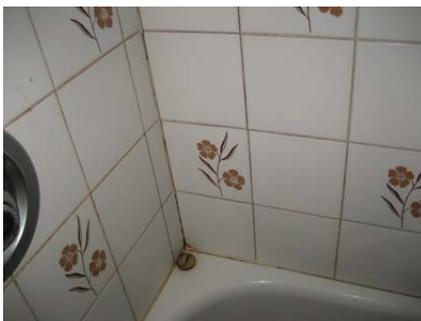
Enamelled metal. Cracked and/or loose grout or tiles noted. This condition may have allowed moisture behind the coverings. Repair or replace as required. Moisture detected with moisture meter.

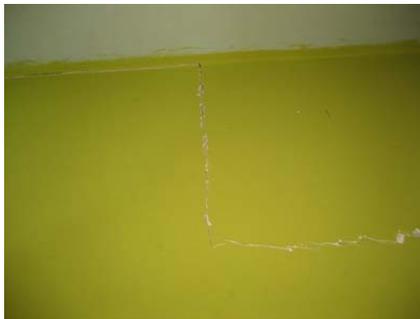
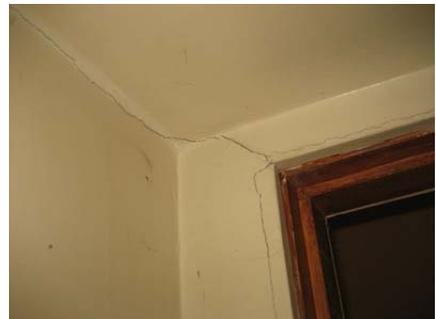
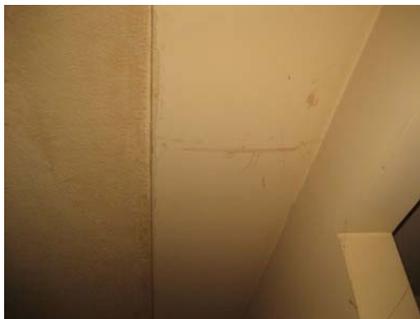
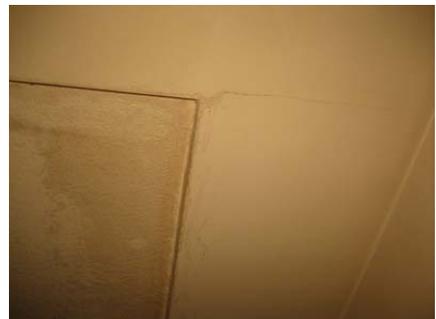
- 901 Floors: Carpet. Sloped/uneven areas noted.
- 902 Walls/Ceilings: Cracks 1/8" noted at several areas due to settling.
Water stains at ceiling located at family room, no water noted but evidence of previous leaks.

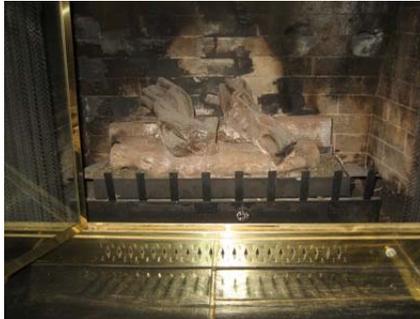
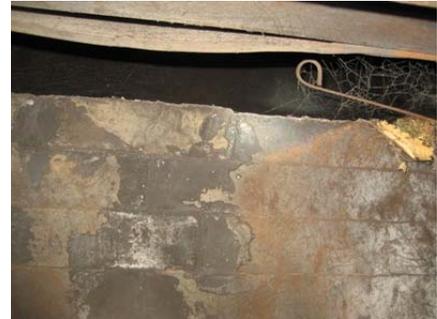
- 907 Heating: Forced air ducts.
 908 Closets: Serviceable.
 909 Stairs/Railings: Serviceable.
 910 Fireplaces: Gas burning. The pilot light was not lit at time of inspection. Pilot lights are not lit by the inspector in case of an appliance/system malfunction. Therefore this inspection is limited in nature. A lot of debris/tree leaves found above damper in the chimney. Recommend regular cleaning and servicing by a qualified contractor.

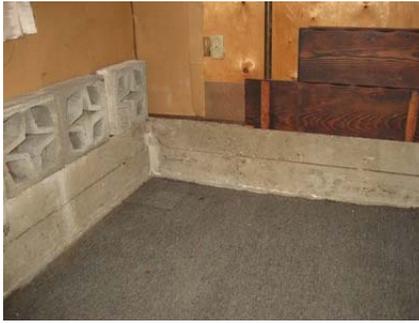
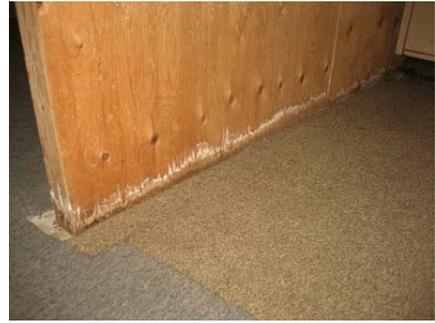
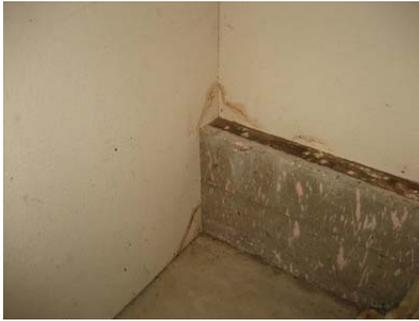
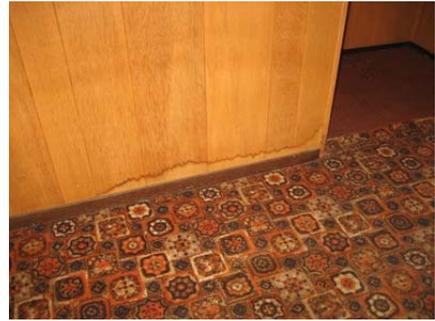
- 941 Floors: Concrete. Carpet. Sloped/uneven areas noted.
 942 Walls/Ceilings: Wall structure appears to be 2x6/2x4 wood stud and the ceiling construction appears to 2x10 wood joist based on the view at left room.
 Efflorescence noted which indicates the past presence of water/moisture at some point in time. Water stains along base of wall, evidence of previous leaks. Suggest contacting vendor for further information.

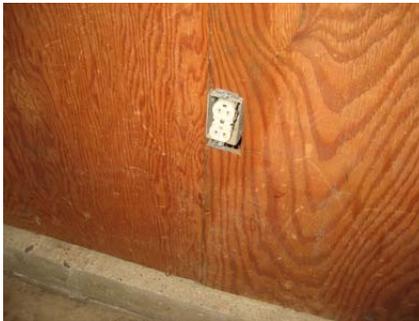
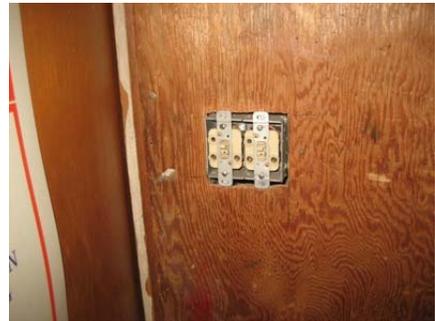
Serviceable.
 Serviceable.
 Ungrounded two or three prong outlets noted. It is recommended that these type of outlets be grounded, replaced with two prong outlets, or protected on a GFI circuit as applicable. Suggest providing face plates on outlets and/or light switches to ensure personal safety.

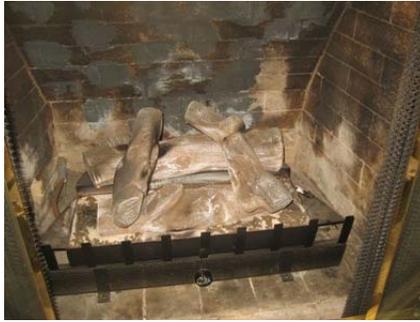
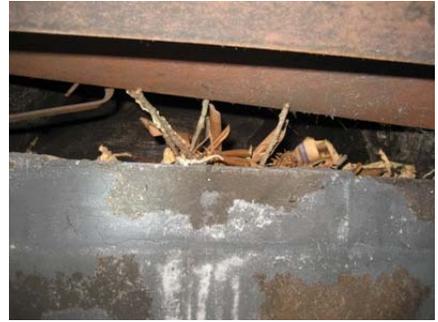
Forced air ducts. No supply air outlet at left room noted.
 Serviceable.
 Serviceable.
 Gas burning. The pilot light was not lit at time of inspection. Pilot lights are not lit by the inspector in case of an appliance/system malfunction. Therefore this inspection is limited in nature. A lot of debris/tree leaves found above damper in the chimney. Recommend regular cleaning and servicing by a qualified

contractor.
